RCRA FACILITY ASSESSMENT

GNB INCORPORATED
2700 SOUTH INDIANA AVENUE
VERNON, CALIFORNIA
CAD097854541

OCTOBER 1990

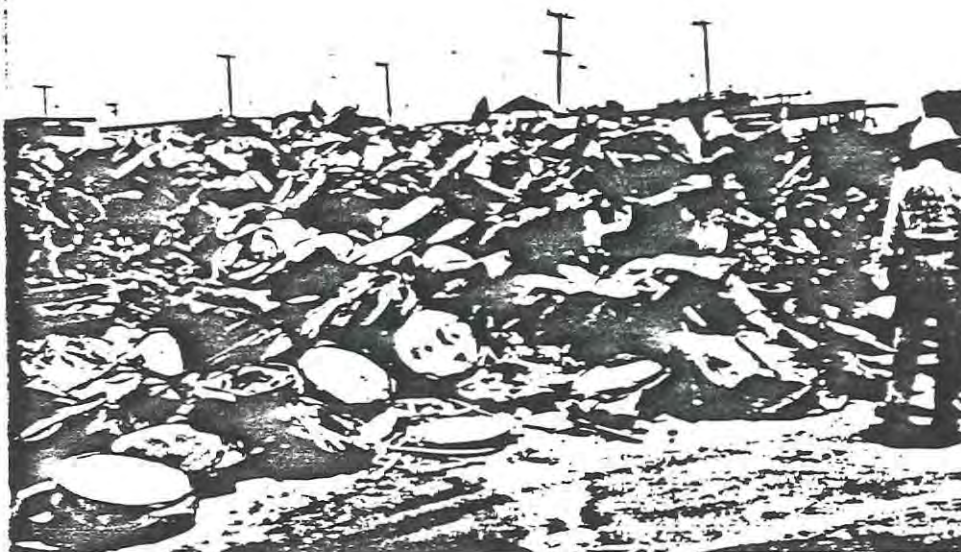
Photo No. 1 Date August 23, 1989 Inspector D. Rasmussen

Description Waste pile of crushed drums located along the western boundary fence. Note leachate stains in foreground with Ken Clark to the right hand side of the picture.

11. Unit 3.29 Crushed Drum Storage Piles
In 1989 DHS has sampled the piles by the western fence and has found hazardous levels of lead and antimony.

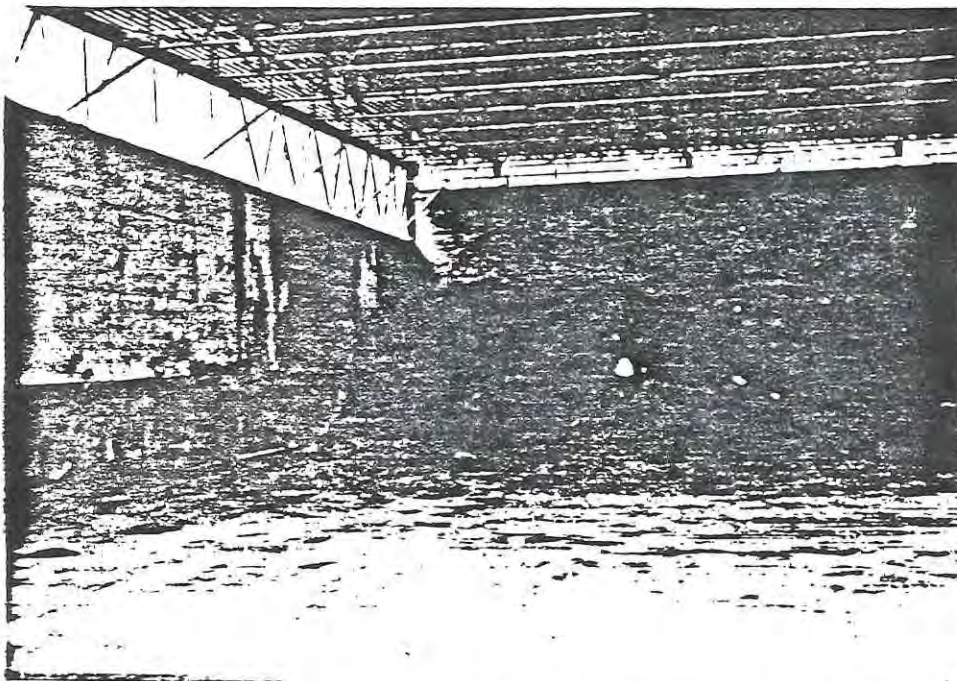
Photo No. 6 Date August 23, 1989 Inspector D. Rasmussen

Description Photo showing hard rubber chip waste pile located in battery receiving/storage shed. Note leachate runoff coming from pile at the right side of picture.

DHS has sampled the pile in 1989 and found hazardous levels of lead in the chip pile and the leachate.

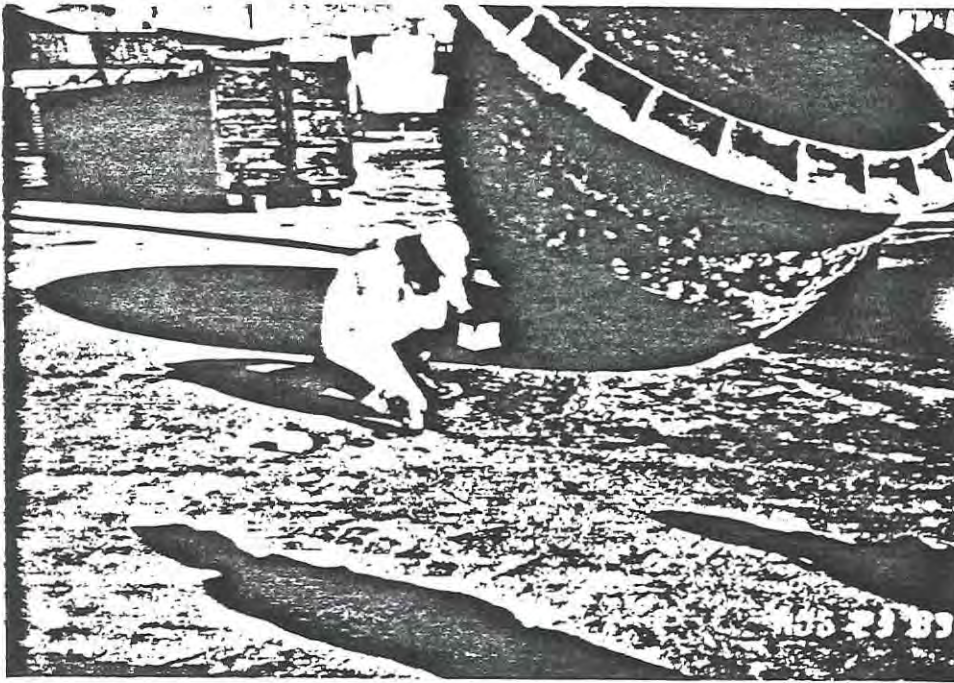
Photo No. 7 Date August 23, 1989 Inspector D. Rasmussen

Description View of discarded smelting pot located in the west yard. Hazardous waste levels of antimony and lead were found in the dust on the ground and in the cauldron.

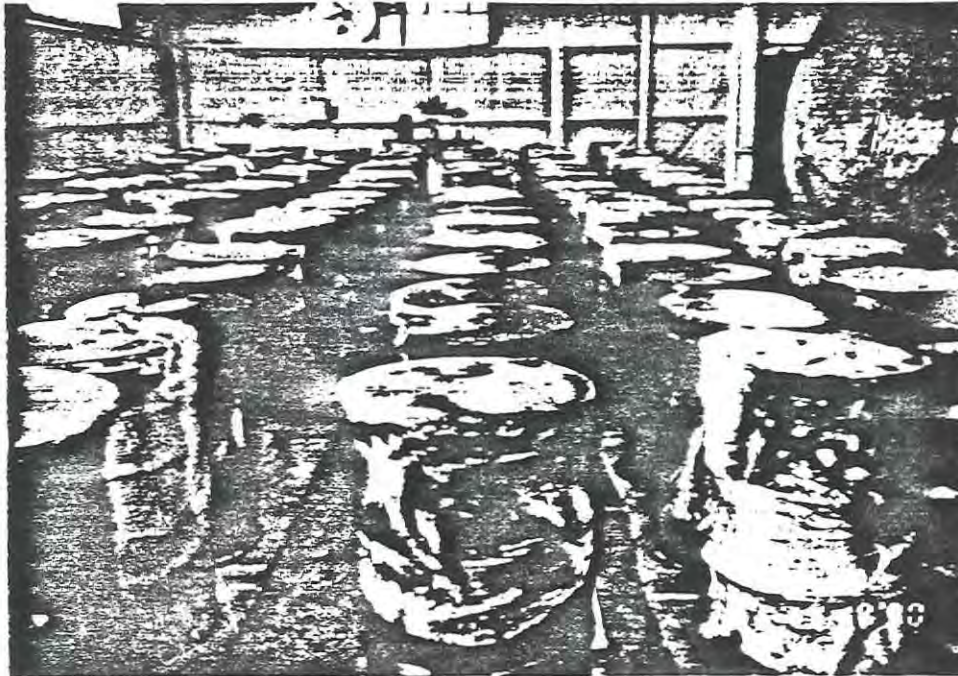
Photo No. 17 Date September 19, 1990 Inspector D. Rasmussen

Description Photo of drums of tin dross hazardous waste in the former lead oxide building.

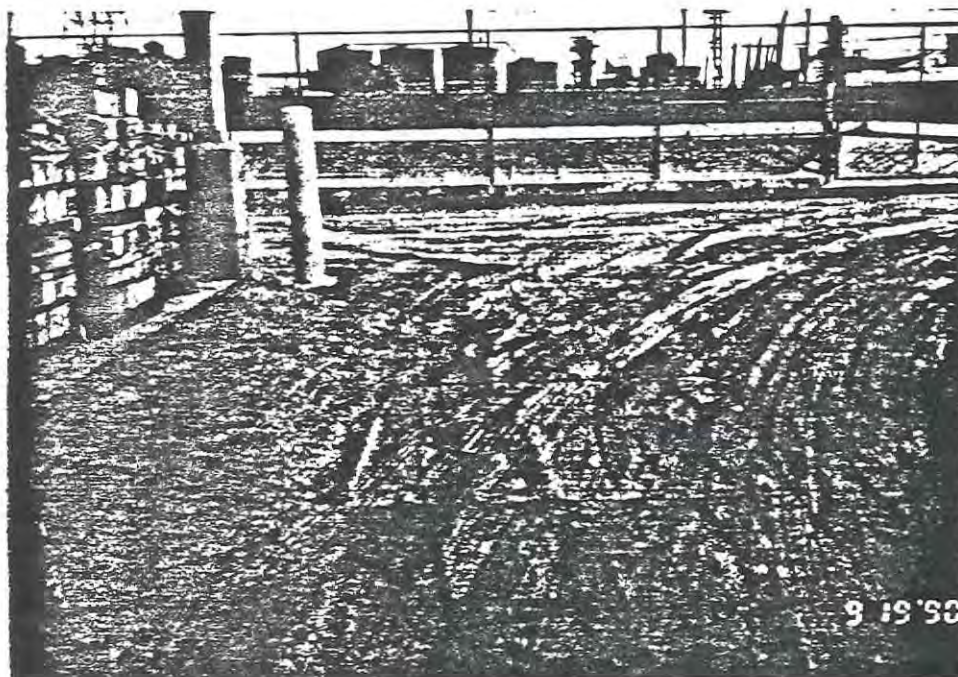
Photo No. 20 Date September 19, 1990 Inspector D. Rasmussen

Description Photo of sump located near the battery storage buildings.
